Manhole Inspection Summary

Manhole # S19I__016MH

Location Address: **1 S PAYSON ST** Cross Street: **BALTIMORE ST**

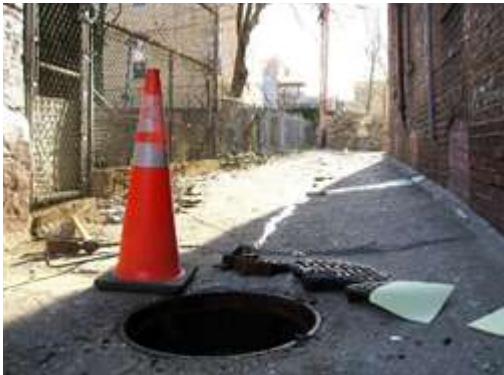
Location View

EVIDENCE OF INFLOW DUE TO SHEETING FROM ALLEY DRAINAGE

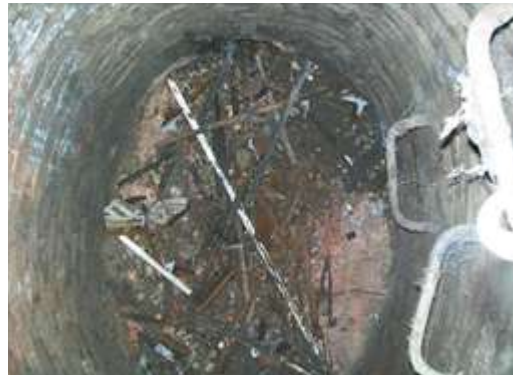
Top View

DEBRIS ON CHANNEL

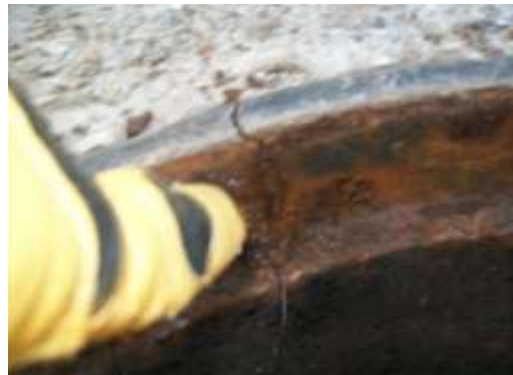
Defect 1

Frame Offset: **0** (in.) Condition: ☐ Sound ☒ **Cracked** ☐ Leaks

FRAME IS CRACKED

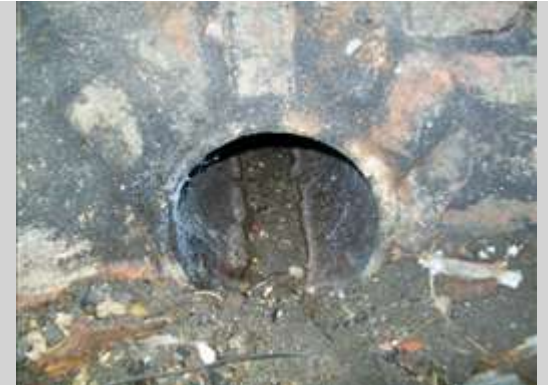
12 O'Clock Outflow

8 in. Circular Gravity Sewer
Pipe Out @ 12 O'Clock
